## **Restoration of Load-Bearing Timber Members Subjected to Fungal Growth: A Case Study of Louhisaari Manor's Roof Truss Structure**

Master's thesis submitted for evaluation in order to finalize master's degree in Building Technology.

Espoo, 21<sup>st</sup> of September, 2019

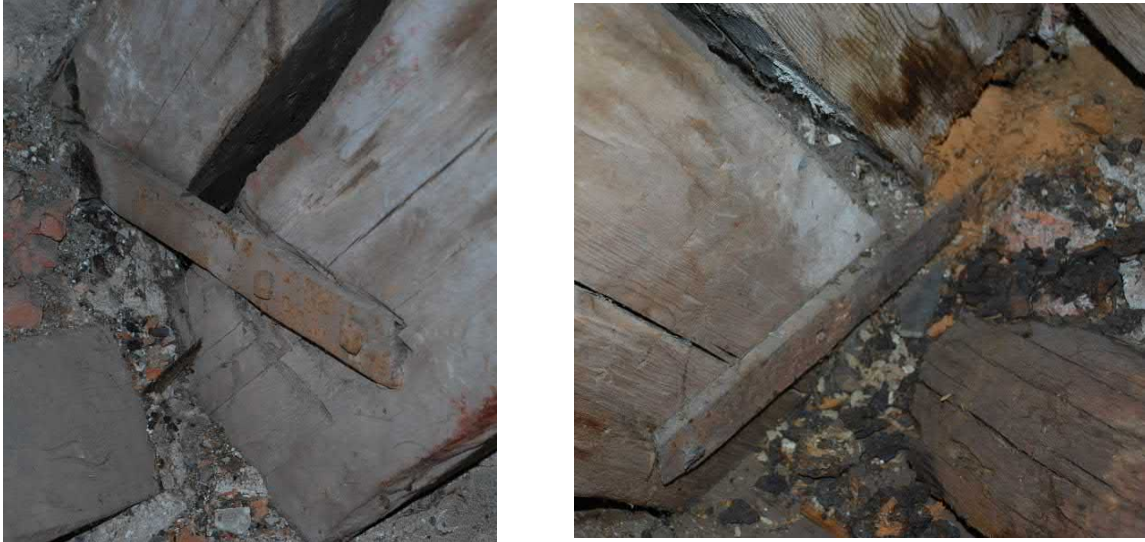
*Figure 33. Rafter S86 on the left and S94 on the right are for unspecified reason connected to the posts of the leaning trestles with flat metal bar. See detail B in Figure 18.*

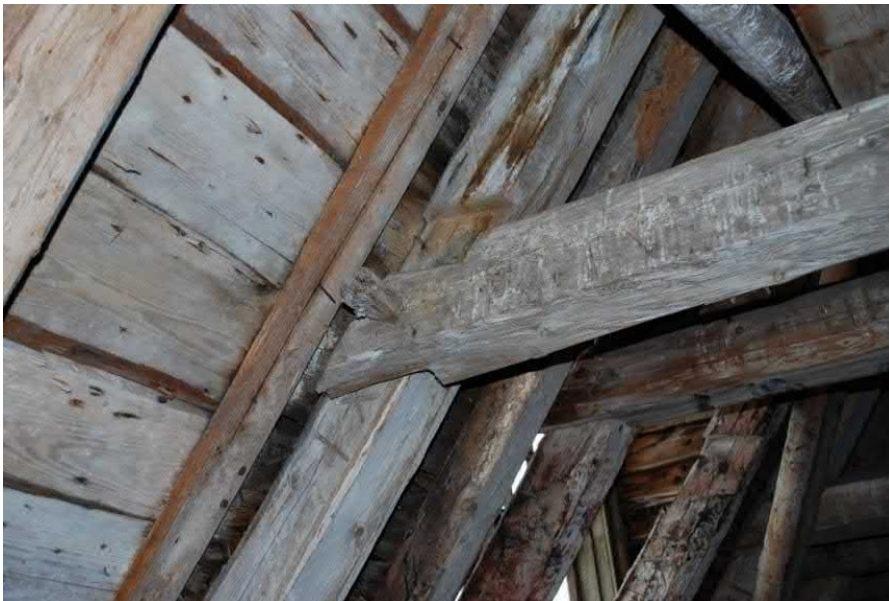
*Figure 34. Connection that has lost its structural capacity. Original markings can be seen on the side of the rafter. Also, one collar beam is entirely missing from its place which can be due to obstacles in between the rafter pairs. See detail C in Figure 18.*

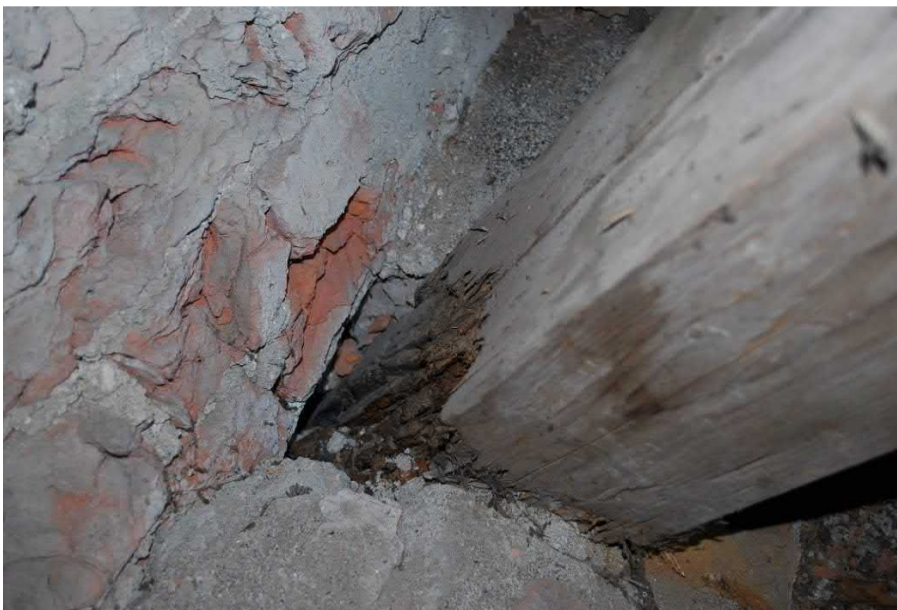
*Figure 35. Rotten rafter S29 penetrating to the masonry wall.*

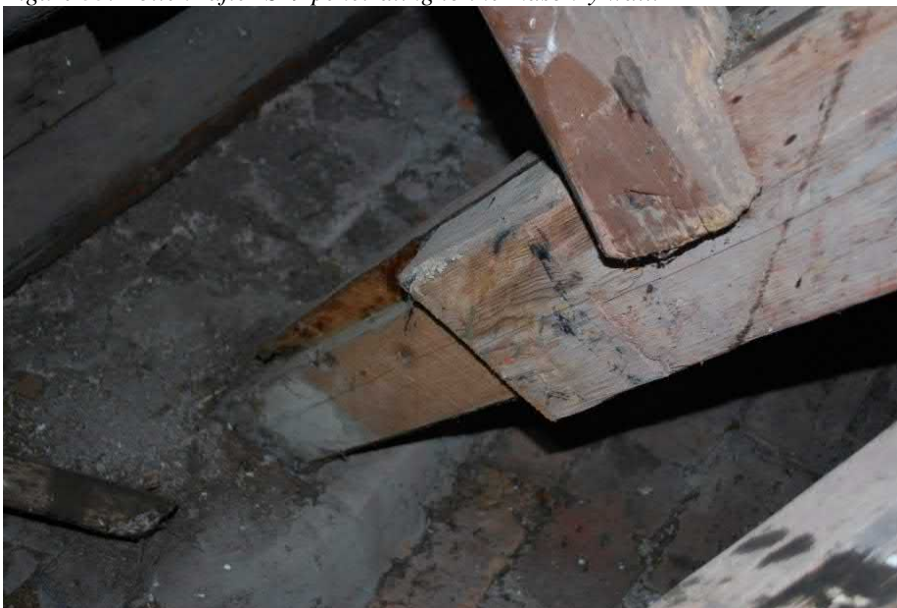
*Figure 36. Previous repair intervention on the end of the rafter S43.*

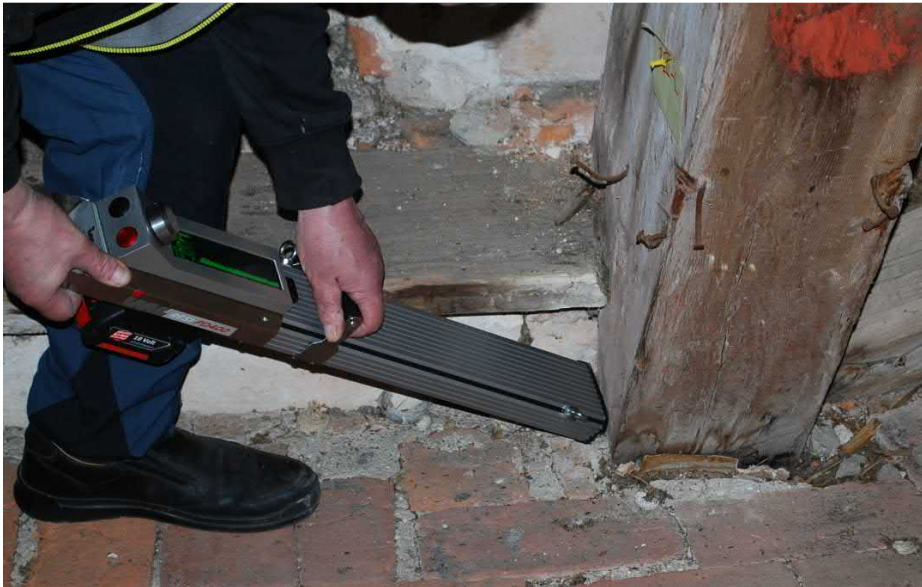
*Figure 40. Resistance drilling performed to the post of the leaning trestle (PIIII) on the southwest side of the roof. The figure also shows that birch bark has been used to protect the embedded parts of the post from moisture.*

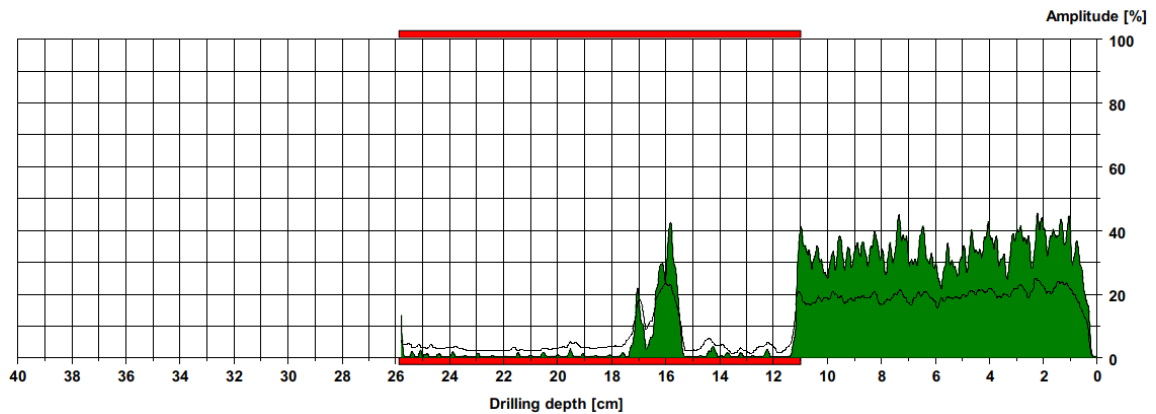
Figure 41. Resistograph profile from tie beam end A36-86L shows clearly that the timber is rotten which can be seen in the drop of resistance drill curve (black) and force feed curve (green area) when the drilling depth reaches 11 cm.

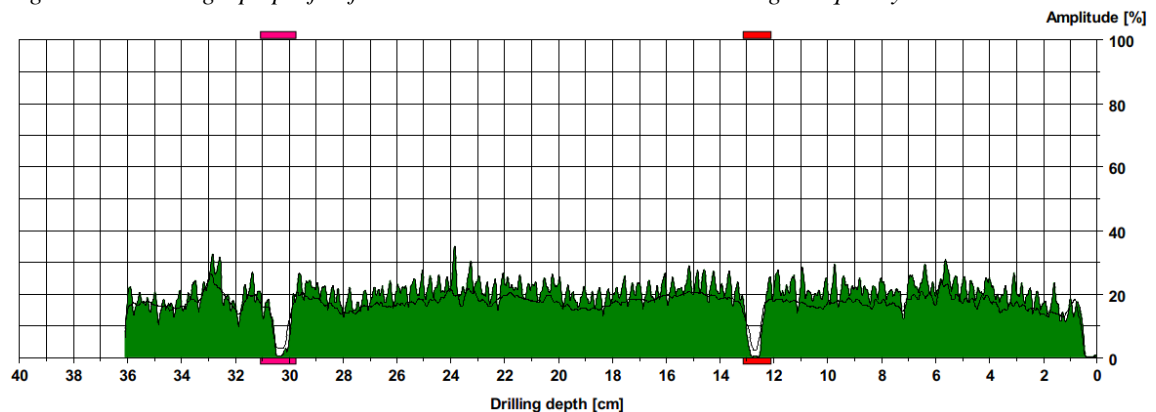
Figure 43. Resistograph profile from the tie beam end A33-89 K shows that the condition of timber can be argued in some drillings.

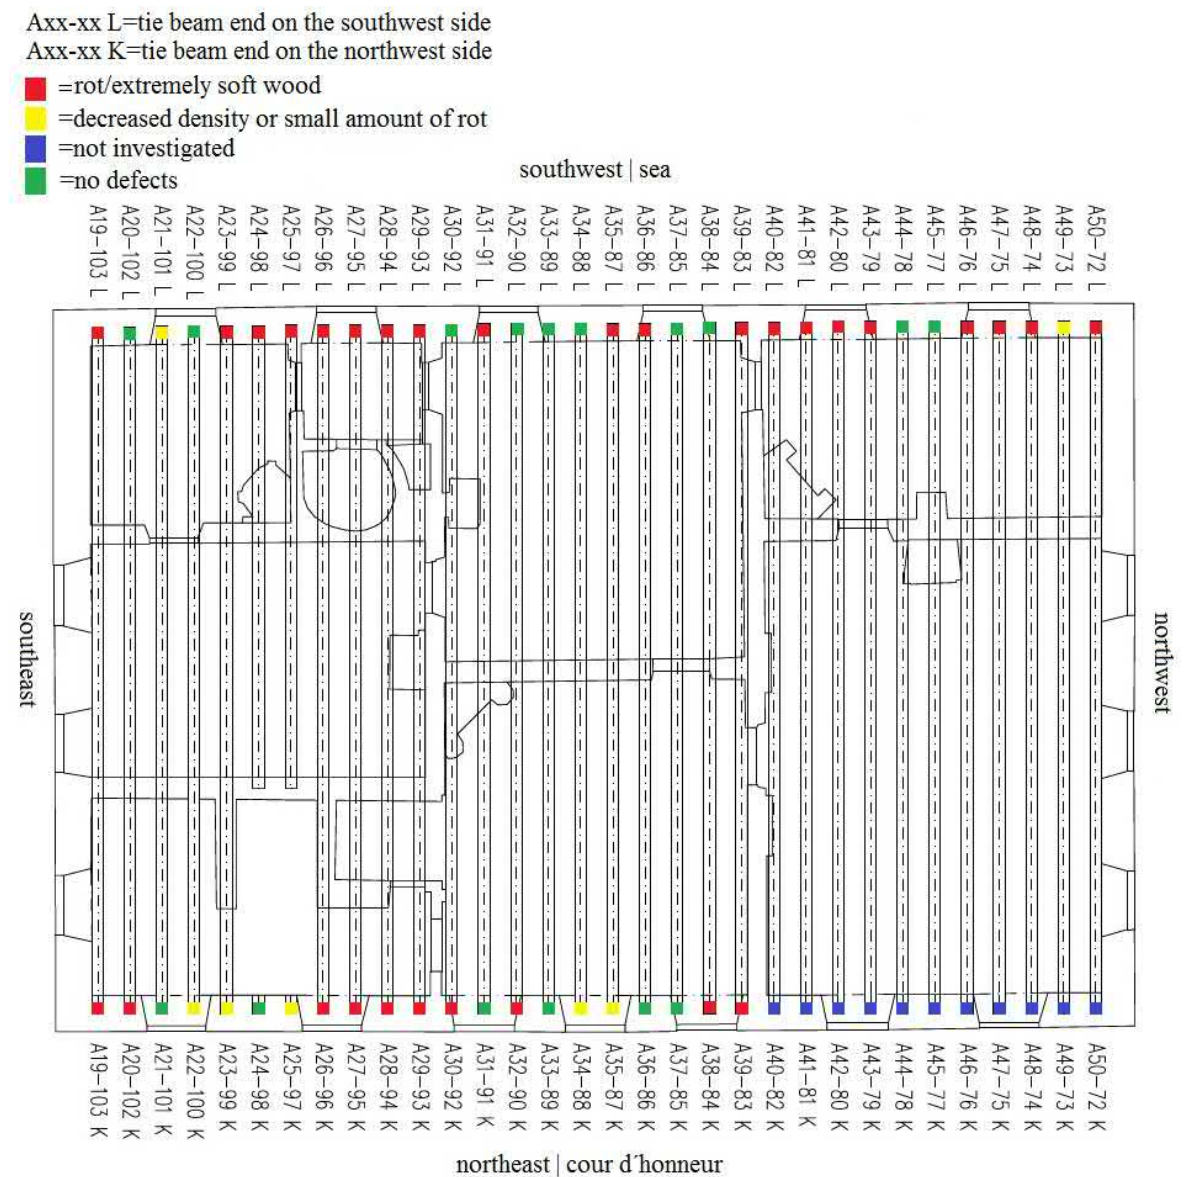
Figure 44. Condition of tie beams ends in the third floor are marked according the resistance drillings.

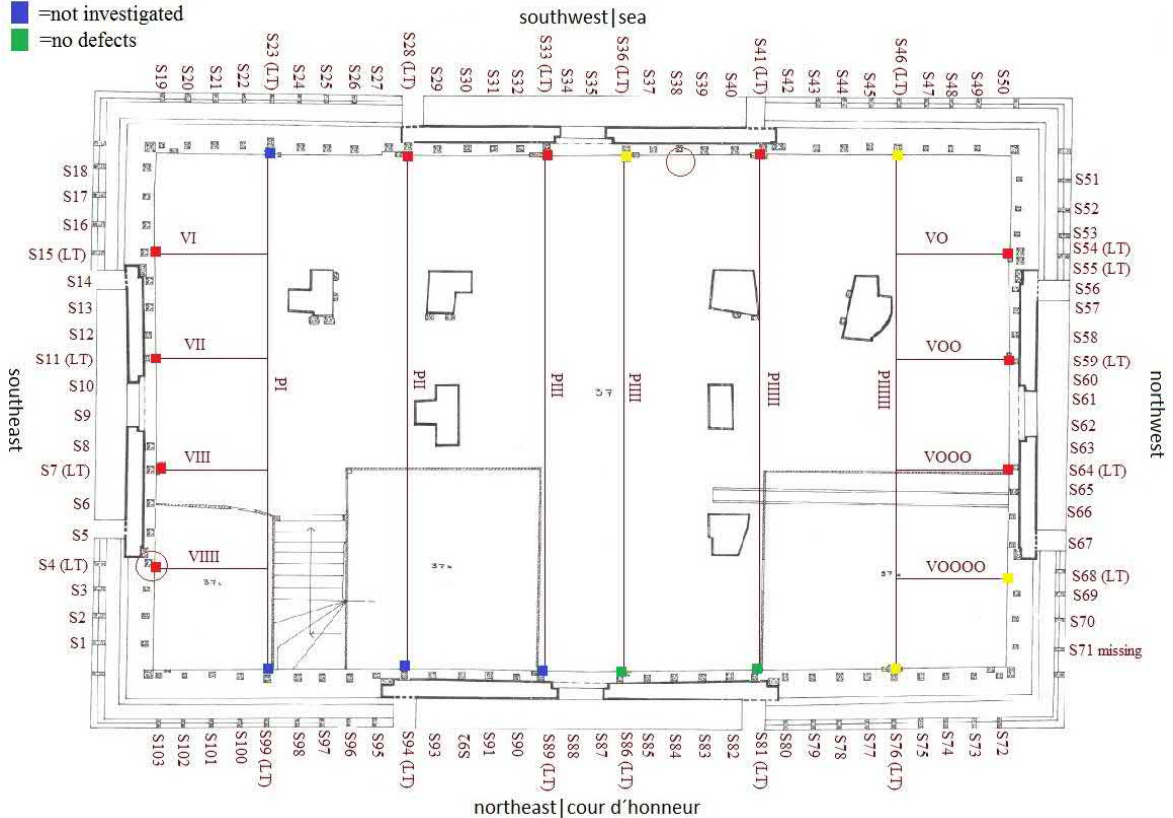
Figure 45. Shows the condition of the posts according to the resistance drillings.

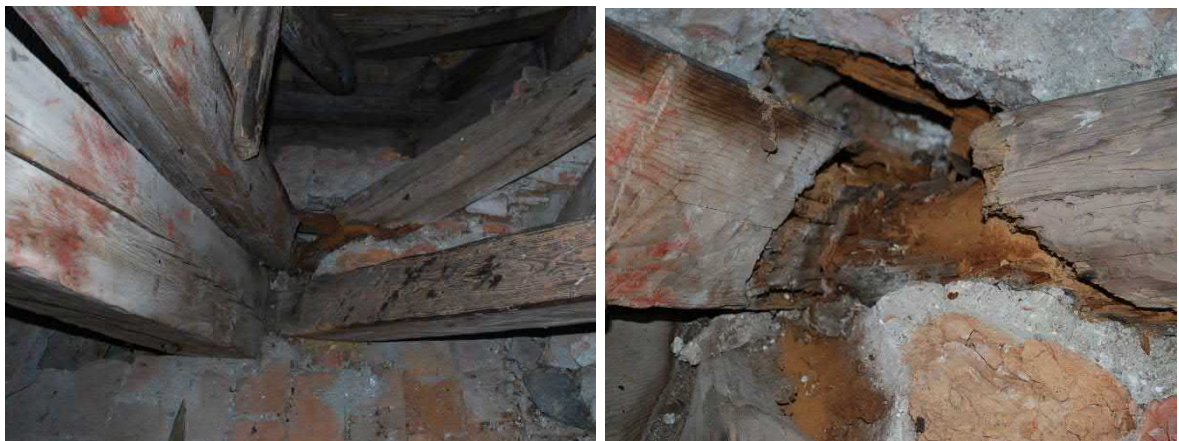
Figure 2. Left: post of the leaning trestle (VIII), rafter (S4), cross bracing and the diagonal timber member that reaches to the top of the gable. Structural opening has been made on the right side of the post. Right: showing the stage of decay more detailed.

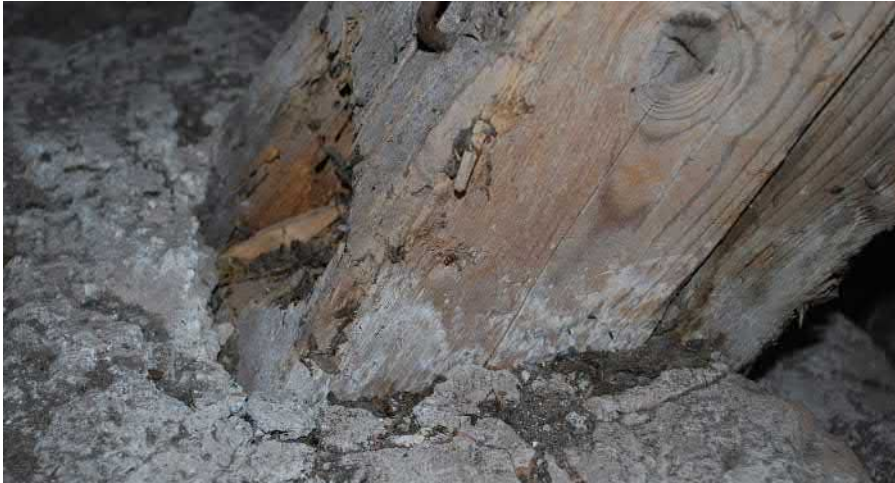
Figure 3. Rotten rafter S18 penetrating to the masonry wall.
