## **Restoration of Load-Bearing Timber Members Subjected to Fungal Growth: A Case Study of Louhisaari Manor's Roof Truss Structure**

Master's thesis submitted for evaluation in order to finalize master's degree in Building Technology.

Espoo, 21<sup>st</sup> of September, 2019

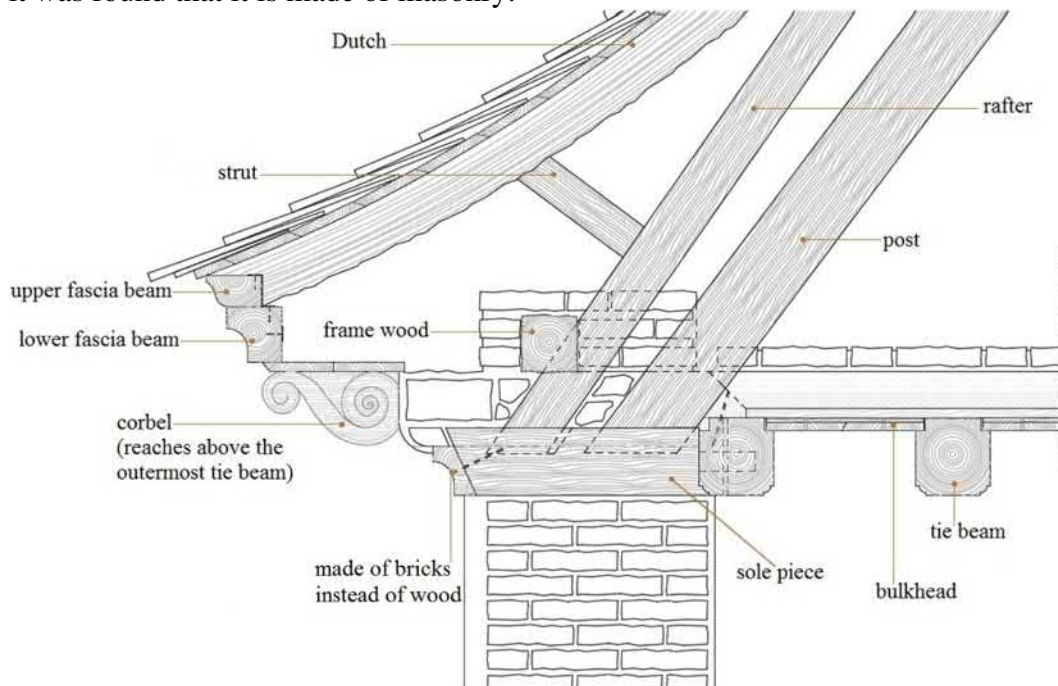
Figure 19. Elevation from the eave structure in the shorter side of the roof. Adapted from the original figure. [1, p. 104] The previous inspection assumed that the batten is made of timber, but it was found that the whole façade is made of bricks.

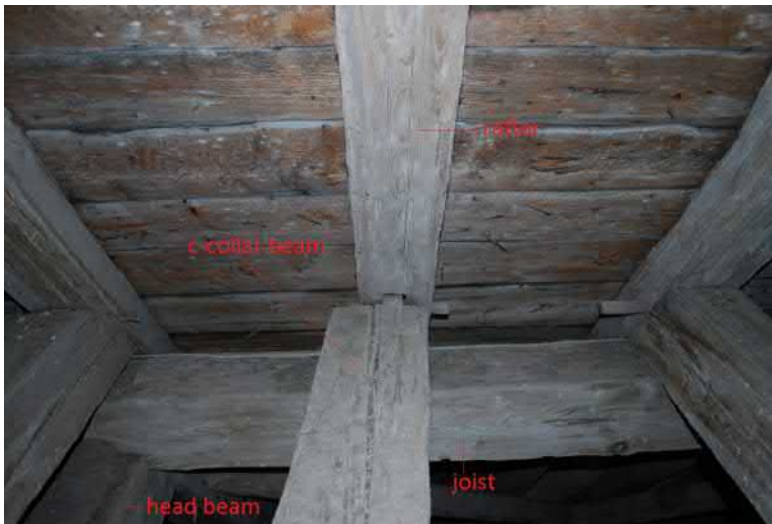
The rafter frame consists of three collar beams (compressive struts), two rafters and a tie beam (tension chord). Some of the collar beams have been cut or notched due to chimneys or other structures that are or have been in the way of collar beams, as can be seen from Figure 22. Rafter frames on the longer side of the roof have approximately 2.5 cm gap between the posts of the leaning trestles but two rafters are leaning on the leaning trestle from the highest point of the posts, which can have an effect on the load paths of the structure in these regions. The rafters on the shorter side have much bigger gaps between the posts of the leaning trestles. The rafters are notched to the frame wood that lies longitudinally inside the masonry wall above the corbels. However, the function of the frame wood is not known. It is possible that the frame wood has given support or longitudinal stiffening to the rafters during construction phase.

Figure 22. Notched joist lying above the head beam. C-collar beam and the rafter is connected with doweled mortise and tenon joint. See detail A in figure 18.

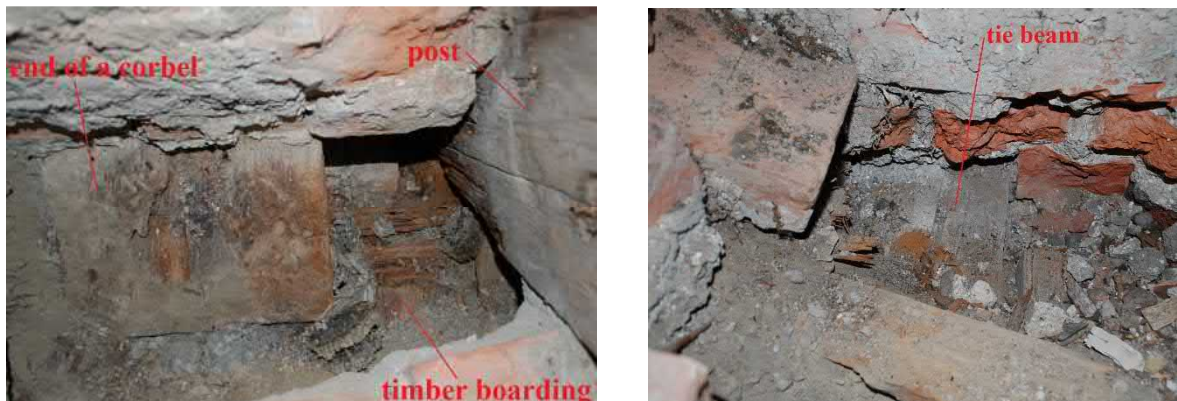
Two structural openings (places marked with a circle in the Figure 37) have been made in the attic during previous inspections to points which had already been damaged due to water leakage and seemed to have been opened earlier also [1, p. 119]. Structural openings show rotten wood inside the masonry wall as can be seen from Figure 32.

Figure 32. Structural openings that have been made in the attic. The left one is in the southeast and the right in the southwest side of the roof.

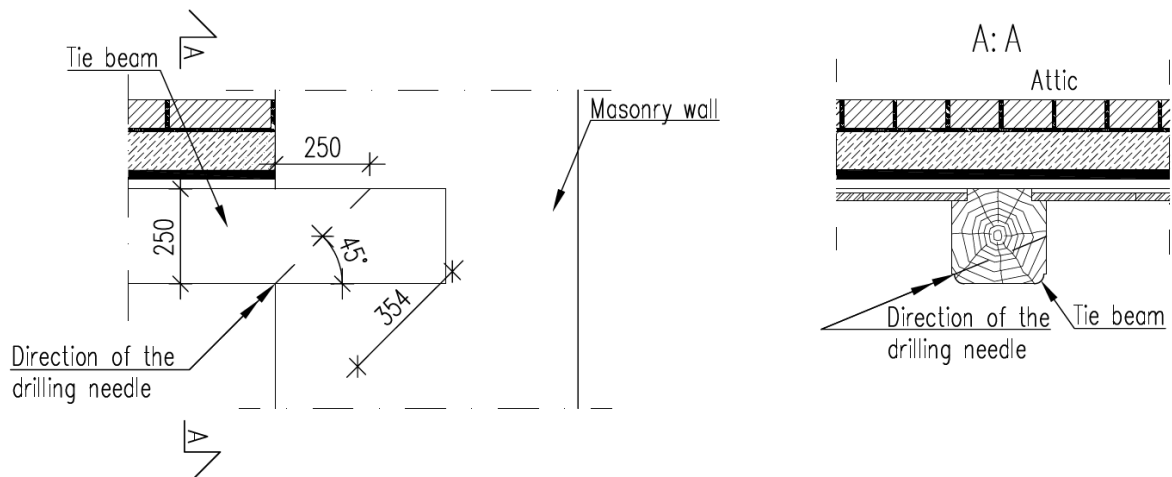
Figure 38. Schematic drawing how the resistance drilling was performed to the tie beams in the third floor. The post and the rafter connect to the tie beam inside the masonry wall even though it is not presented in this figure.

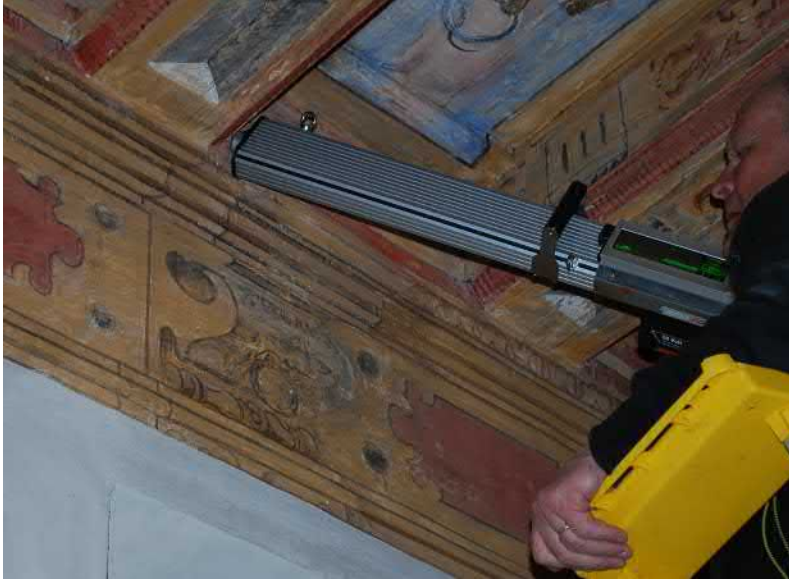
*Figure 39. Resistance drillings taking place with Resistograph on the tie beam end in the third floor of Louhisääri manor.*

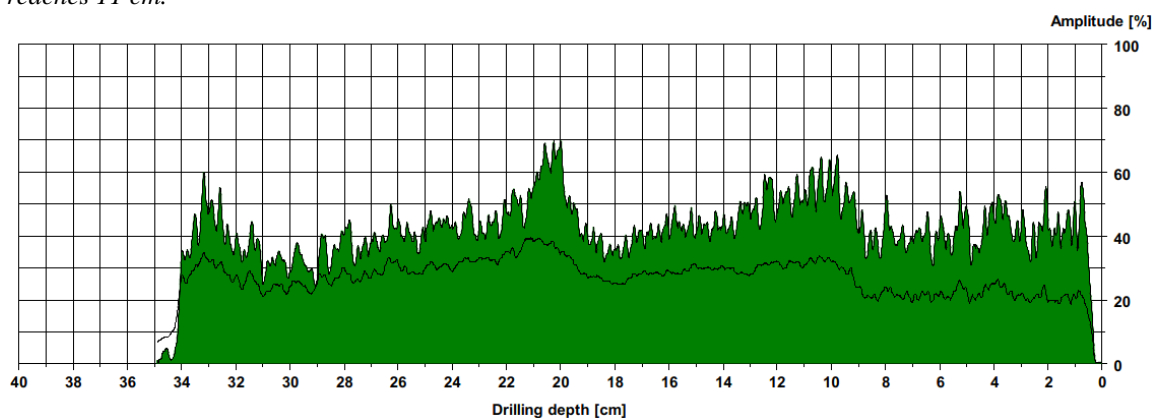
Figure 42. Resistograph profile from the tie beam end A44-78 L shows good quality timber.

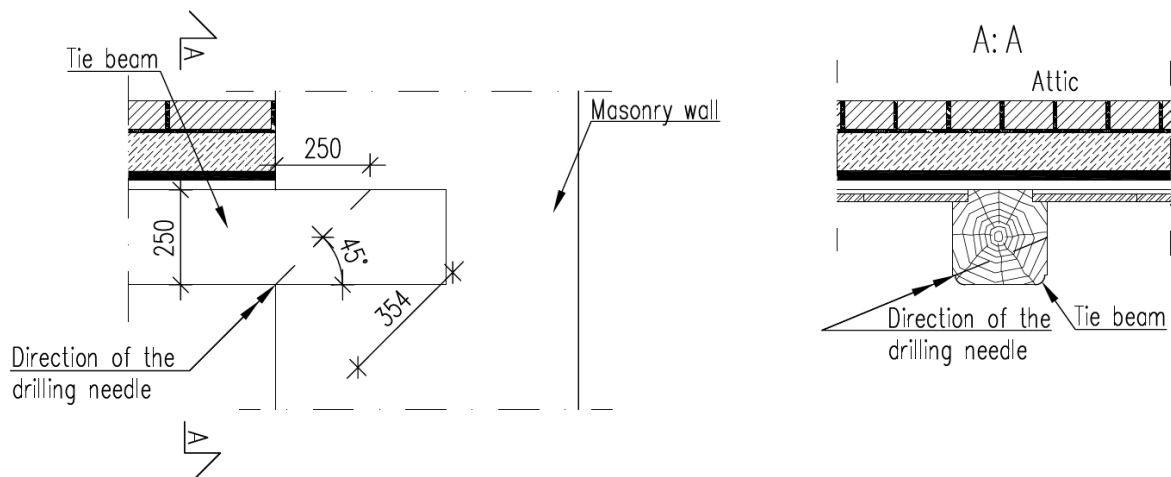
Figure 1. Schematic drawing how the resistance drilling was performed to the tie beams in the third floor. The rafter and the post connect to the tie beam inside the masonry wall even though it is not presented in this figure.

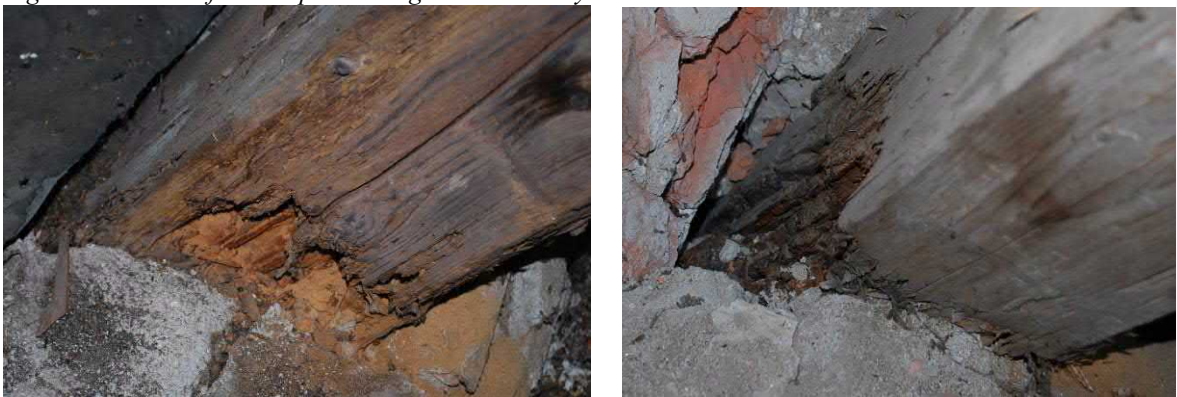
Figure 4. Left: rotten rafter S26 penetrating to the masonry wall. Right: rotten rafter S29 penetrating to the masonry wall.
